Analysis and Design Challenges Associated with the Catagunya Dam Restoration Project

Tony Harman, Richard Herweynen and Malay Ghosh

Design Manager Catagunya Dam Restoration Project, Hydro Tasmania Consulting

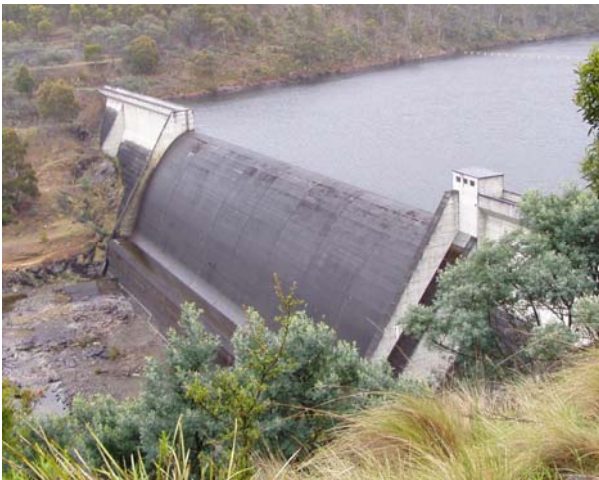
Catagunya Dam was constructed from 1957-1961, is 49m high and has a crest length of approximately 280m (refer to Figure 1). Design and preliminary construction work were commenced early in 1957 for a mass concrete gravity dam. However, following a visit to Europe in 1957 by the Hydro Electric Commission's Chief Civil Engineer, the option of a post-tensioned concrete gravity dam was seriously considered. As a result it was estimated that a post-tensioned dam provided a saving at Catagunya in the order of 20 per cent of that for a conventional gravity dam (Wilkins & Fidler, 1959). As a result of the cost advantage, a decision was made to construct Catagunya Dam as a post-tensioned concrete dam, where removed concrete volume was replaced by 412 no. x 200 ton capacity, high tensile steel cables anchored to the dolerite foundation rock. At the time Catagunya was the highest post-tensioned concrete dam in the world.

Figure 1 – Catagunya Dam Prior to the Dam Restoration Project Works

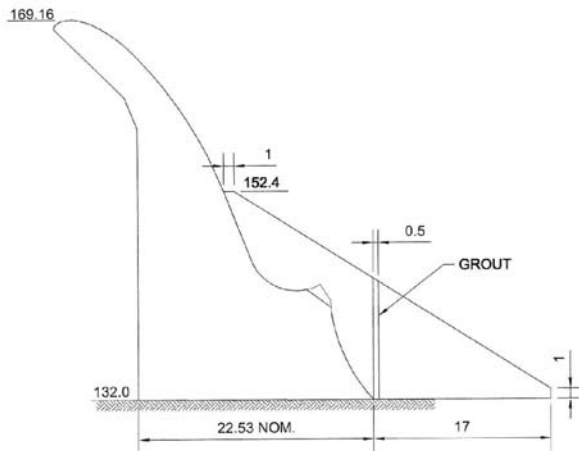
As part of the initial options study the Buttress option was analysed as an equivalent block for a cantilever analysis, refer to Figure 2 below.

Figure 2 - The Buttress Solution with the Composite Block Section Analysed

COMPOSITE SECTION AFTER GROUT FILLED

The buttress concept was for two buttresses supporting each dam block. Each buttress was 2m wide, 20m maximum height and maximum base length of 17 m. In order for the original dam and buttresses to 'act as one', a procedure was devised to ensure that integration was achieved for all ambient and load conditions. In general terms, the procedure involved partially unloading the dam by lowering the reservoir prior to integrating the new buttress concrete with the existing dam. Either infill grout or concrete was required to achieve this integration while the storage was low and the dam at its optimal seasonal displacement during favourable ambient conditions.

Prior to the infill, with the storage lowered, the dam moves upstream and the dam and buttress acts as non composite separate structures. The gap is then filled with grout / concrete, cured, then the water raised to full supply level. Composite action now takes place. The stress distribution at the base will be on the basis of the combined moment of inertia. The total stress at the base will be the linear addition of composite and non composite action of the dam and buttress.

A unique issue with the spillway section of Catagunya Dam is the cantilever design of the crest (refer to figure 2). This crest cantilever is a reinforced concrete element which had been designed for the self weight loads should the reservoir level drop. In order to install the large post-tensioned anchors in the spillway section a large portion of the tensile reinforcement for this cantilever needed to be cut to install the anchor block. Therefore the concrete that remained in place between the 1200mm diameter anchor block holes needed to be strengthened to ensure that the cantilever remained structurally adequate. The final solution that was adopted for this was to strengthen the spillway cantilever with carbon fibre bars prior to the holes being cut for the anchor blocks. The design detail required cutting 4 vertical grooves 14mm wide x 90mm deep into the dam spillway face extending equidistant upstream and downstream of the line of anchors. In each groove, 6 / 8mm diameter carbon fibre rods were to be installed by embedment in epoxy with sufficient cover to protect from exposure. In order to ensure effectiveness of this new reinforcement combined with the remaining existing reinforcement, installation was to be performed when the spillway face stress was close to zero. Given the importance of this reinforcement to the integrity of the dam crest and the fact that carbon fibres had never been used for this purpose the following was undertaken:

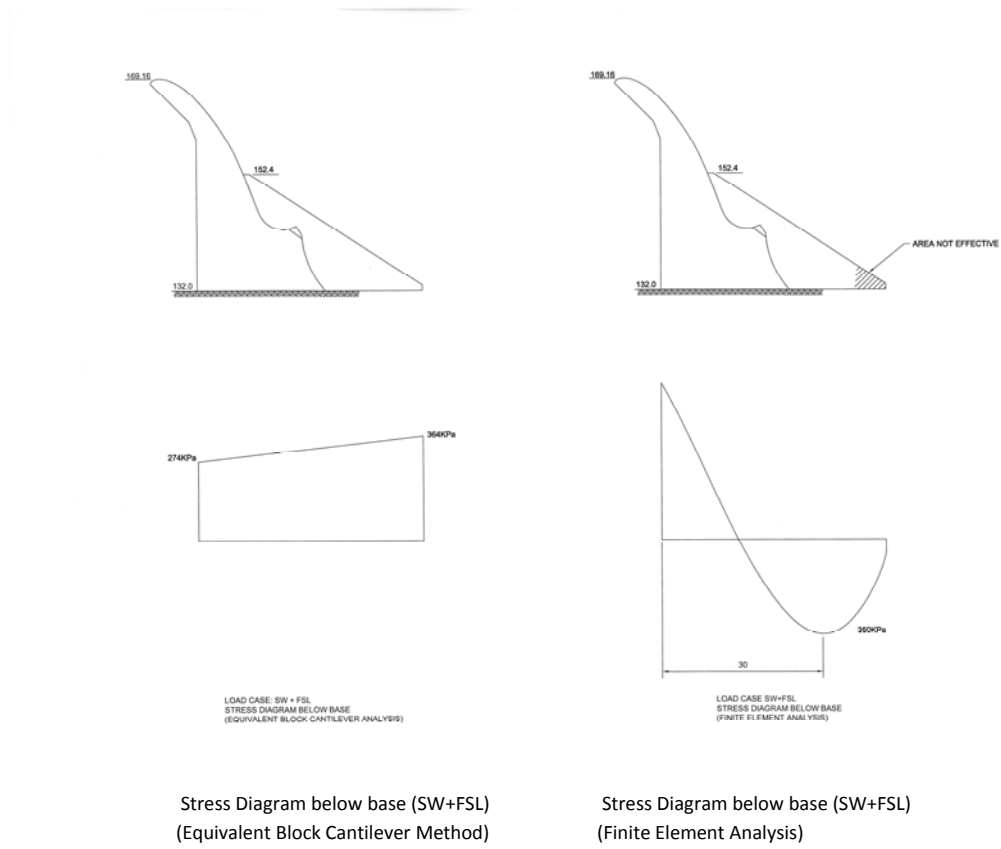
Following the initial options study, the design for the Buttress solution was further developed with detailed finite element analysis (FEA). Based on this analysis the preliminary details developed in the initial option study were proven to be inadequate as the tail of the buttress was shown to be ineffective (ie. the load as shown by the principal stresses going vertically into the foundation). This is shown in Figure 3 below, where the simplified, cantilever block analysis uses the full length of the buttress, while the finite element analysis indicated that the tail of the buttress was not being used resulting in a significantly reduced lever arm. With a significantly reduced lever arm, tensile stresses are generated at the upstream heel of the dam.

As a result the lever arm adopted in the preliminary calculations was too long and increasing the length of the buttresses did not help.

Figure 3 - Comparison between stress diagrams from simplified analysis and FEA

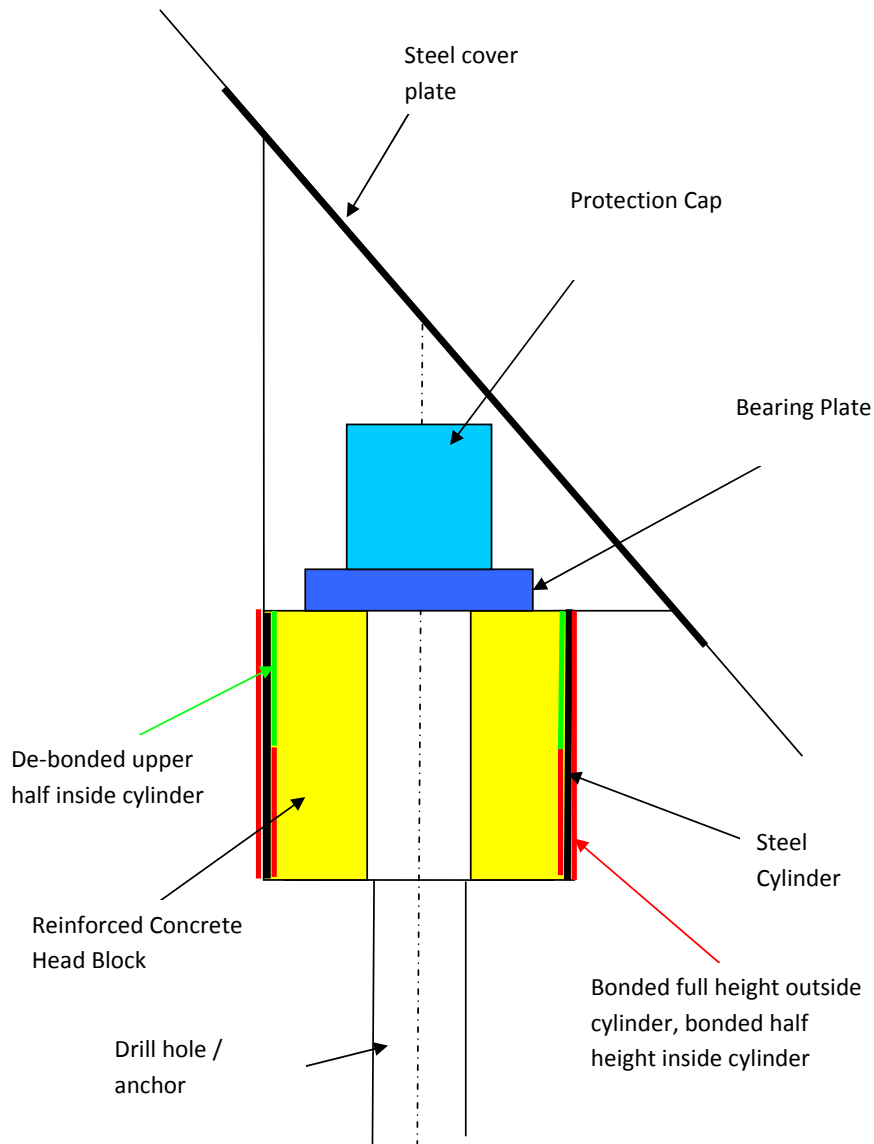
A typical spillway anchor head block (refer to Figure 4) is 1200 mm diameter by 1200 mm deep precast reinforced concrete encased in a steel cylinder. There are 7 anchors per block spaced at 2177mm apart. As the anchors are closely spaced, we needed to know the group load effect on each block due to a full set of anchors. FEA was performed in the head block region and surrounds, to gain a full understanding of the stress fields, in particular the bursting stresses and local stress effects at the termination of the anchor head bond. 3 cases were modelled including base bonded, half bonded and full bonded head blocks. Results showed that bursting stresses could be readily controlled within the head block and rapidly diminished below the head block. High local tensile stresses (> 4 MPa) surrounding the termination of the bond required special attention.

A solution was derived to cast the head block in a steel cylinder where the internal interface concrete / steel was bonded for the lower half but debonded for the upper half. The complete precast unit was designed to be installed in the cored hole in the dam so the cylinder exterior was fully bonded by epoxy grout. This detail would theoretically prevent local high tensile stresses occurring surrounding the base and walls of the cylinder but would transfer the vertical stress component over the height of the cylinder. The internal bond termination could not then initiate cracking in the dam concrete at this point as stresses are dispersed by the cylinder.

Anti burst reinforcement in the head block was determined by conventional theory and cross checked with the FEA results. Reinforcement was determined excluding the hoop steel effect of the cylinder. This is particularly relevant in the upper half, as this region is debonded. For the lower

half, antiburst reinforcement is more than required due to the combined effect of the internal reinforcement and the cylinder which is integrated with the internal concrete by means of shear studs.

Figure 4 - Typical Spillway Head Block

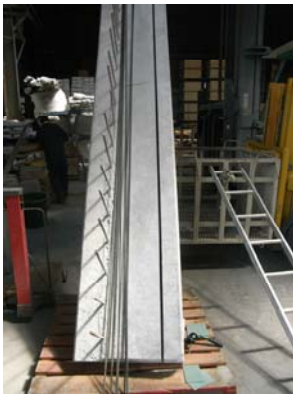
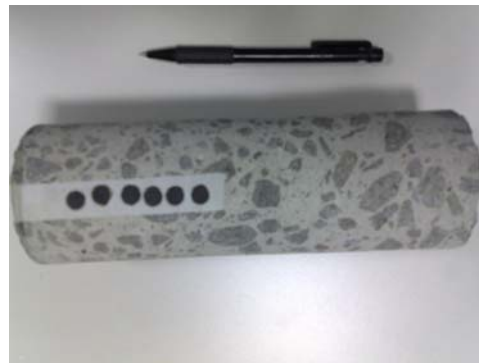
- A trial installation beam was constructed (see Figure 5). A single groove of dimensions 14mm x 90mm deep was cut and 6 / 8mm rods were installed in epoxy. Upon curing, the beam was cored through several locations to visually reveal the effectiveness of the epoxy encapsulation of the carbon fibre and the epoxy to concrete bond (see Figure 5). The trial results revealed success with the methodology so the detail was adopted as the final design.
- The behaviour of the dam crest cantilever was analysed to determine the reservoir level which would result in zero stress at the downstream face location of the carbon fibre reinforcement. This was determined to be close to the normal operating level of the reservoir, where the moment generated by the self weight is balanced by the opposite moment generated by the uplift under the overhang section.

Figure 5 - Test beam on the left & core sample on the right
