## eNews September 2013

<b>TITLE</b>	<b>: Westernport Water - Candowie Reservoir Upgrade Project (CUP) – The Story So Far</b>
<b>AUTHORS</b>	<b>: Geoffrey Allum - Senior Engineer Development : Chaminda Jayasena - Senior Project Manager</b>

### 1. PROJECT SUMMARY

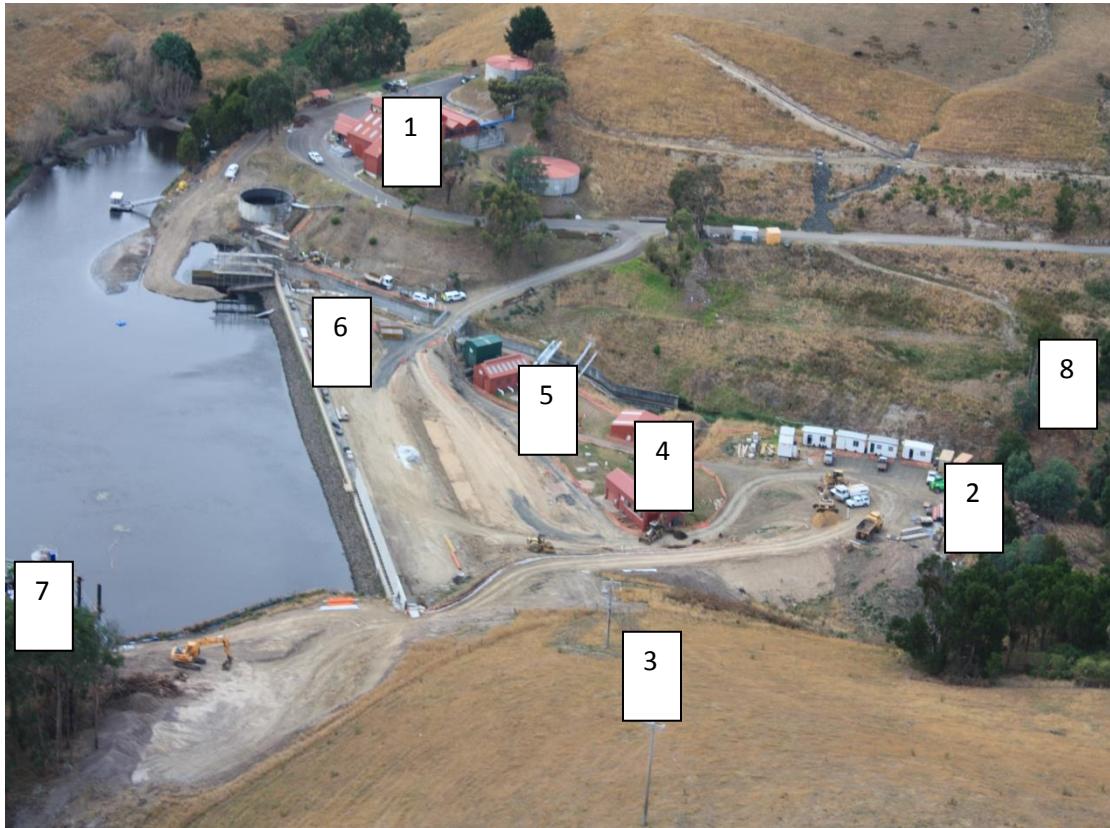
*Figure 1. Aerial view of construction showing the water treatment plant at the top of the picture (1), the main construction compound at the right(2), red building in foreground is pump station to reticulation(3), red building just above is a treatment chemical building(4), red building to left of chemical building is pump station to the treatment plant(5), spillway is immediately on left abutment below treatment plant(6), outlet tower is lower left side (7) and photo is taken from right abutment. The only road to site is in middle to right (8) that is to be shared by the treatment site and all construction traffic.*

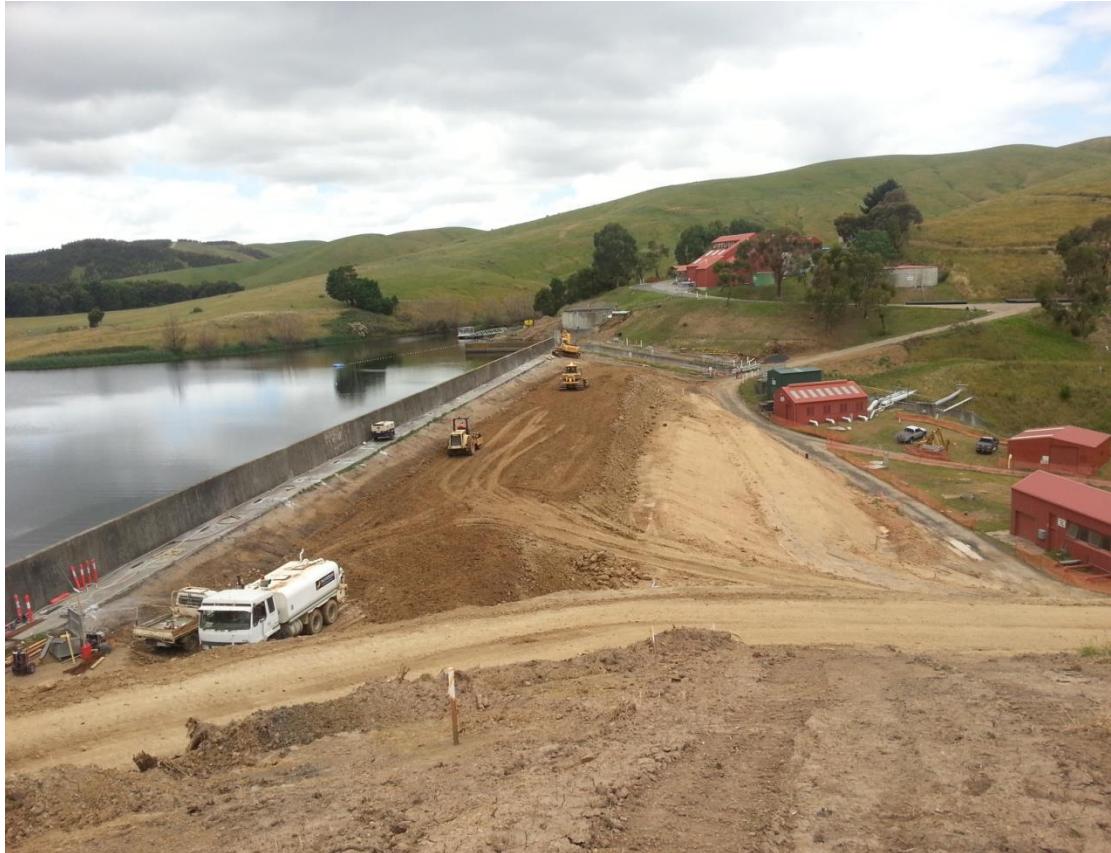
*Figure 2. Finalisation of compaction on the downstream earth embankment including raising the chimney filter to full height and width of the new embankment.*

- i. Upgrade of Candowie Reservoir to current ANCOLD standards for flood and earthquake protection including;
  - a. Embankment stability requirements

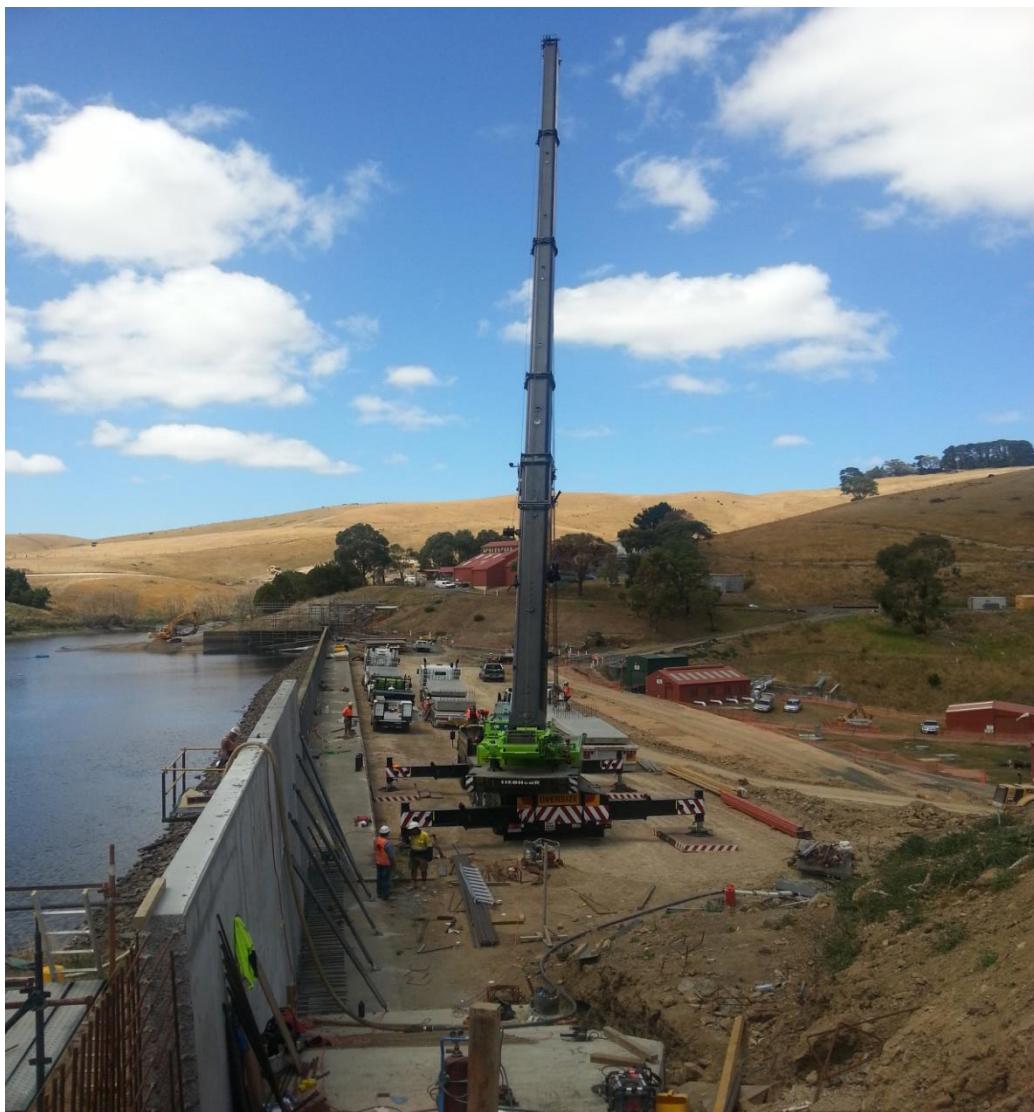
*Figure 3. Installation of precast concrete parapet wall panels that were manufactured off site, craned into position and sealed to the existing parapet wall.*

- b. Use of pre-cast concrete panels to form new parapet wall

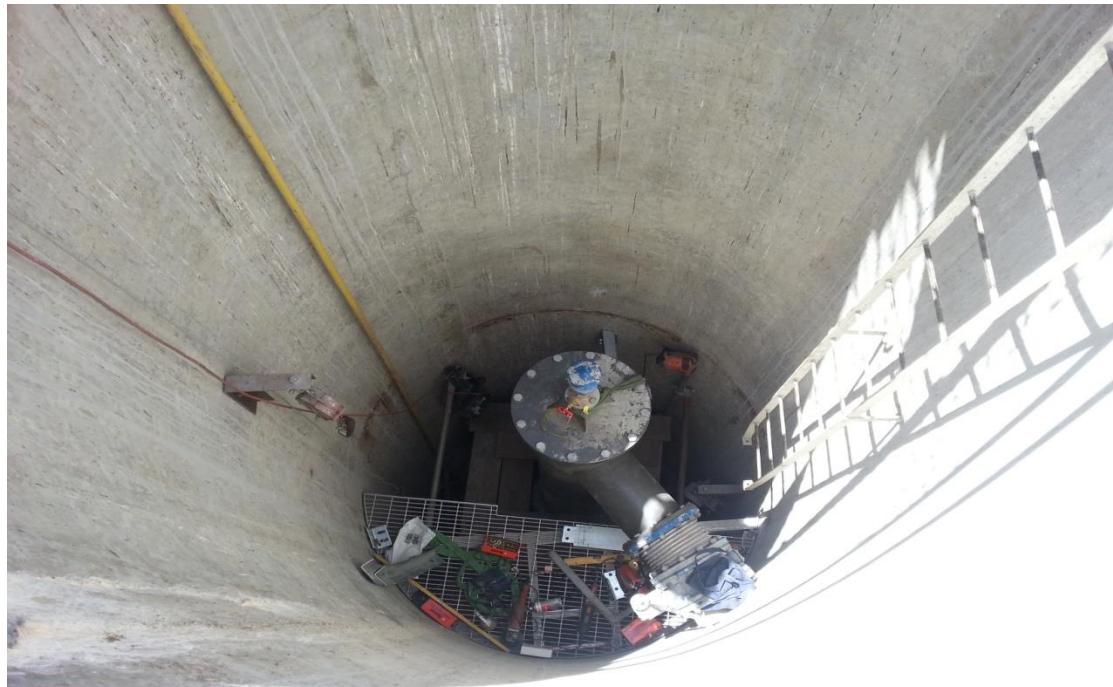
*Figure 4. (below) Inside the inlet tower showing new pipework and platforms being installed.*

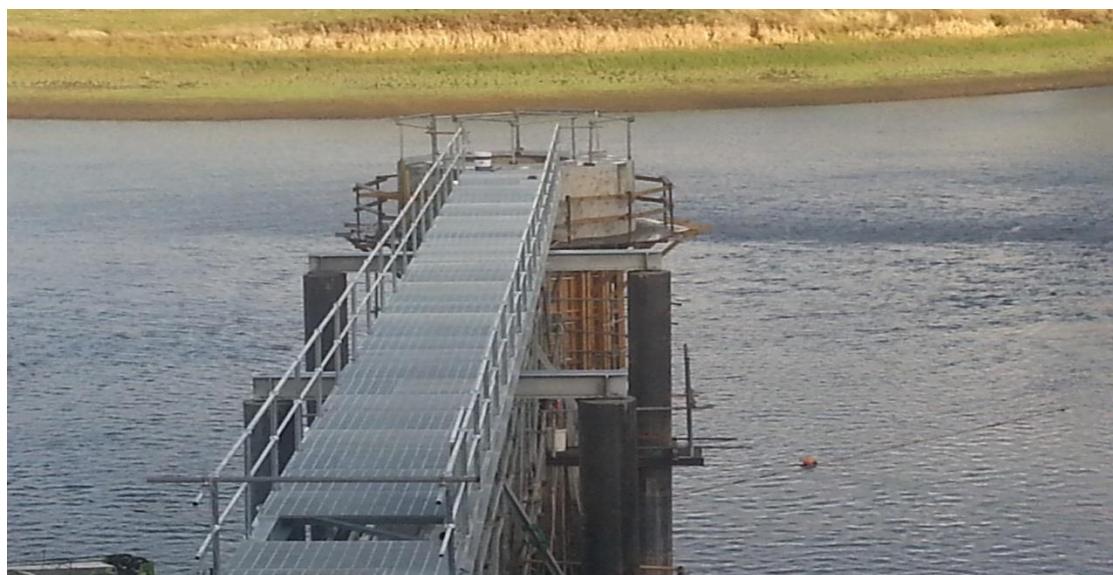
*Figure 5. New walkway and extended outlet tower before installing ground anchors*

c. Post-tensioning of existing Outlet tower for dynamic loads

- iv. Undertaking ground anchoring and post-tensioning of a “live” Outlet Tower. This involved core drilling to confirm geotechnical conditions, precision placement to clear fittings around the tower, control of spoil to avoid interruption of water draw-off to allow the treatment plant to operate supplying water to customers. The steel anchors are currently being drilled and fitted to the new raised outlook tower and will provide an upgrade to the dam safety ensuring the outlet tower can survive an earthquake event.

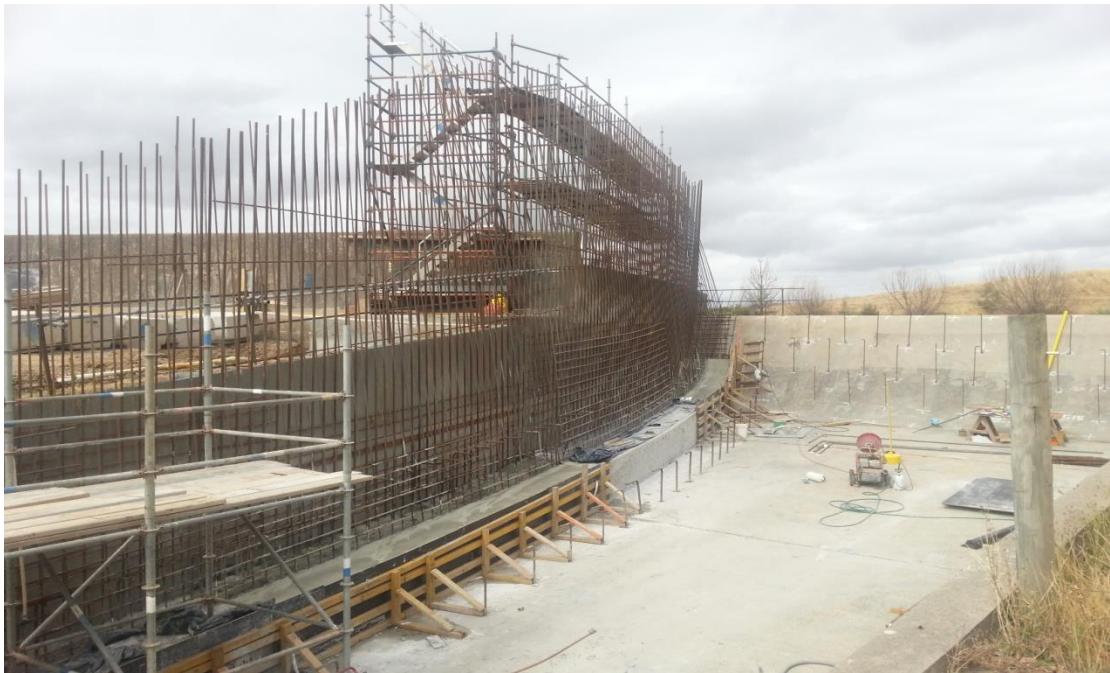
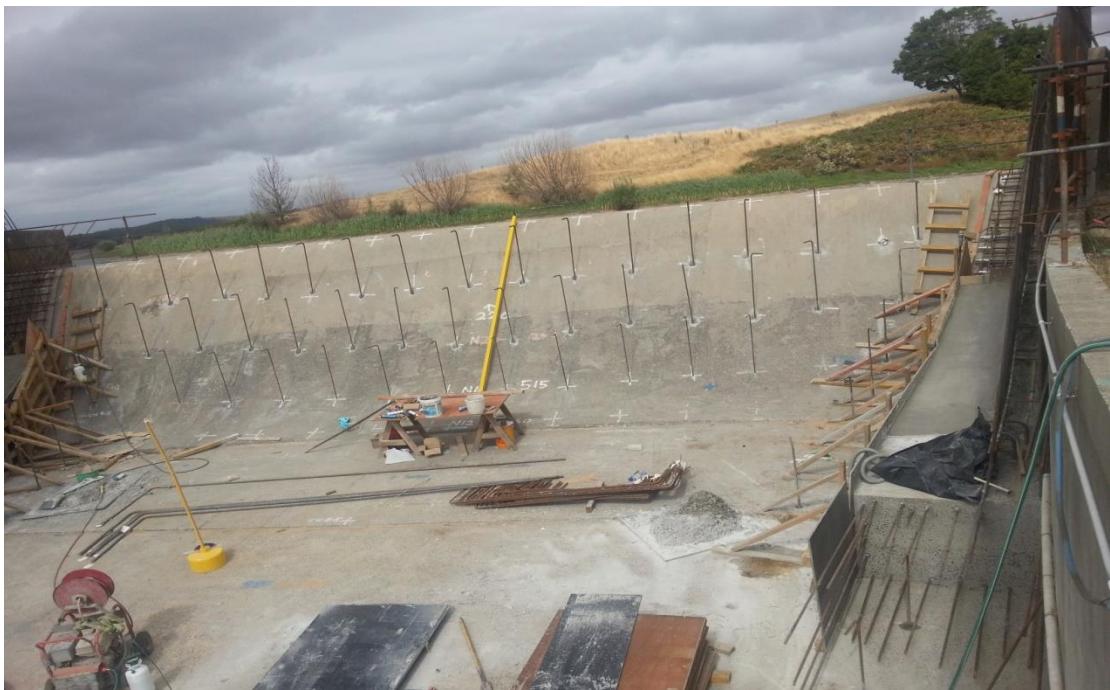
Figure 6. (Top) Right side of spillway wall showing reinforcement being prepared for concrete pour, Figure 7. (Bottom) Preparation of existing spillway, starter bars, to increase height of ogee crest by 3 metres.

d. Spillway design for 1:100,000 year flood

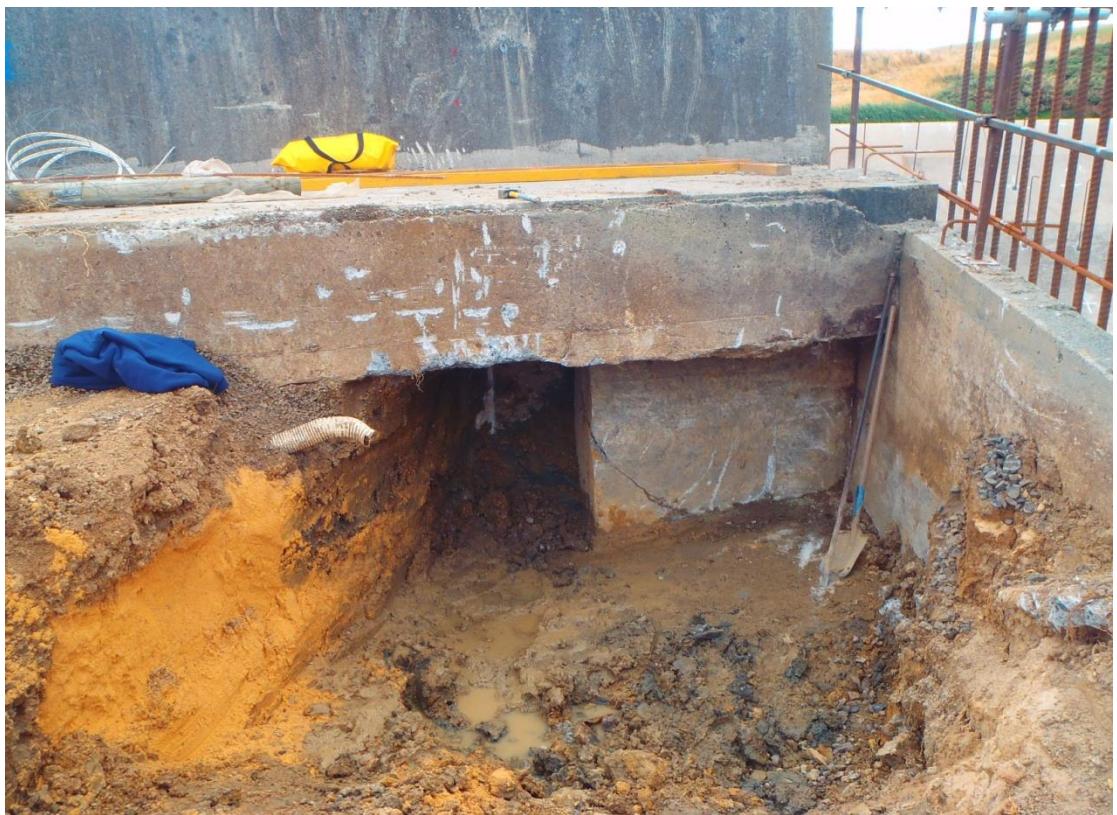
- ii. Difficulties created by incomplete records on existing structures as plans were old and incomplete or did not show some details. The photo below shows the parapet wall, the right hand side of the spillway wall and the excavation to determine what was originally built in this location. This was required as there was a persistent leak in this area through the

spillway wall joint. The concrete block supporting the slab panel was not shown on the original plan and did not extend to the original parapet wall upstream of this position. The joints were resealed and the hole filled with concrete.

*Figure 8. Excavation of filter and existing parapet wall to determine leakage path*

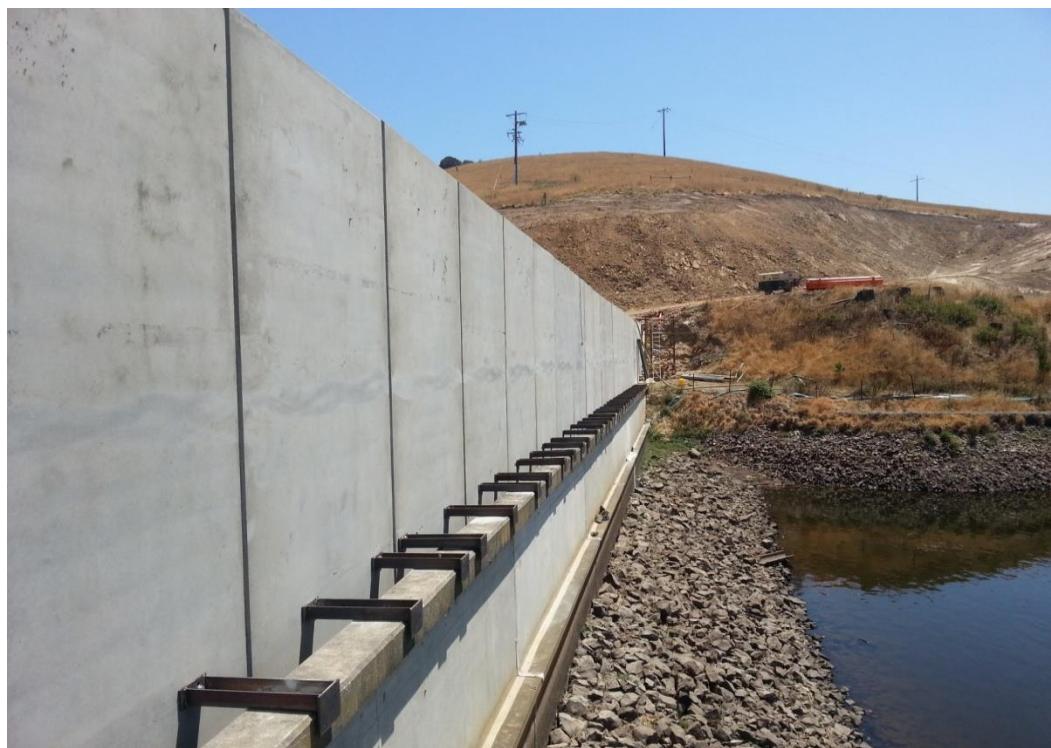
- iii. Integration of new and old parapet walls and ensuring a watertight structure that required careful preparation of the joints and sealing of the joints between the old parapet walls and the new parapet walls. Photo below shows the joint between the old parapet wall and the newly constructed wall on the upstream face.

*Figure 9. Construction of precast parapet wall*
